QUALITY IS KEY

This article was written by Lee Davies, Group Technical Manager, CA Group Limited on behalf of MCRMA. This article first appeared in RCi May 2013

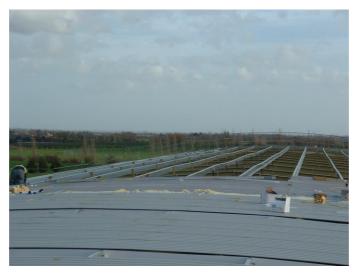
Image 1: Undulating/out of position purlin

The images shown here represent some of the current issues facing roofing contractors. In image 1 (see page 1) undulating/out of position purlins occur when the steel frame is erected at varying heights from rafter to rafter. In this case, rafters are facetted to suit a self-curved twin skin roof cladding system and varying heights of cleats are welded to the facetted rafters to achieve the required curvature. Clearly, a difference in height of the rafters / cleat positions does not achieve the correct purlin lines throughout the roof construction.

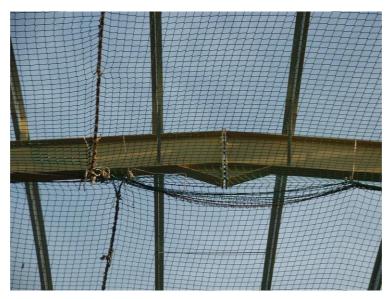
Image 2: Incomplete structural connections

Image 2 (see page 2) shows incomplete structural connectors where the hip purlins are not connected at hip rafter cleats; this not only affects structural capabilities but in addition, there are no structural 'cleaders', which are required to ensure non-fragility of the roofing assembly and an air tight junction being achieved.

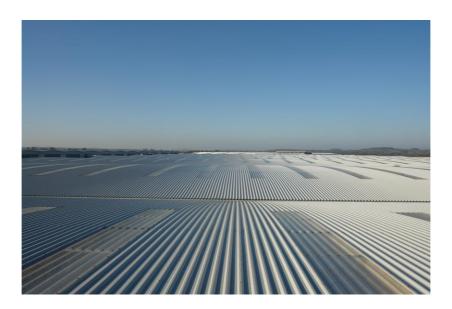
Image 3: Example of good installation and workmanship. Image courtesy of CA Group

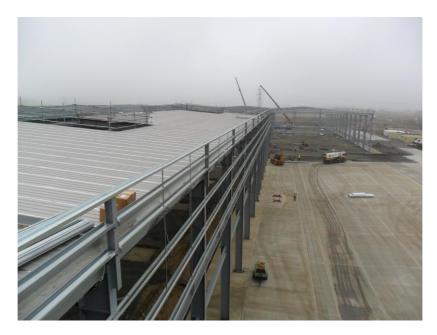
Image 4: Primary and secondary steelwork properly installed
