Guidance document GD 07

## INSTALLATION AND QUALITY OF WORKMANSHIP

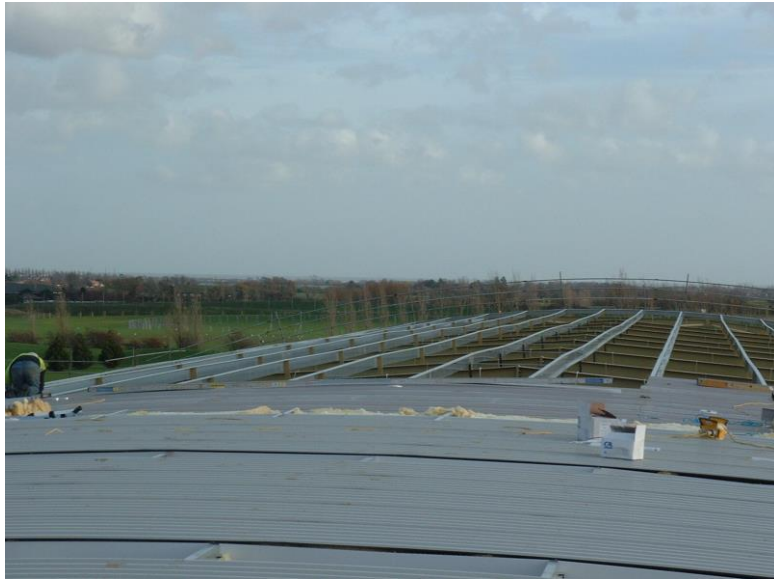
*Image 1: Undulating/out of position purlin*

Undulating/out of position purlins (image 1) occur when the steel frame is erected at varying heights from rafter to rafter. In this case, rafters are faceted to suit a self-curved twin skin roof cladding system and varying heights of cleats are welded to the faceted rafters to achieve the required curvature. Clearly, a difference in height of the rafters / cleat positions does not achieve the correct purlin lines throughout the roof construction.

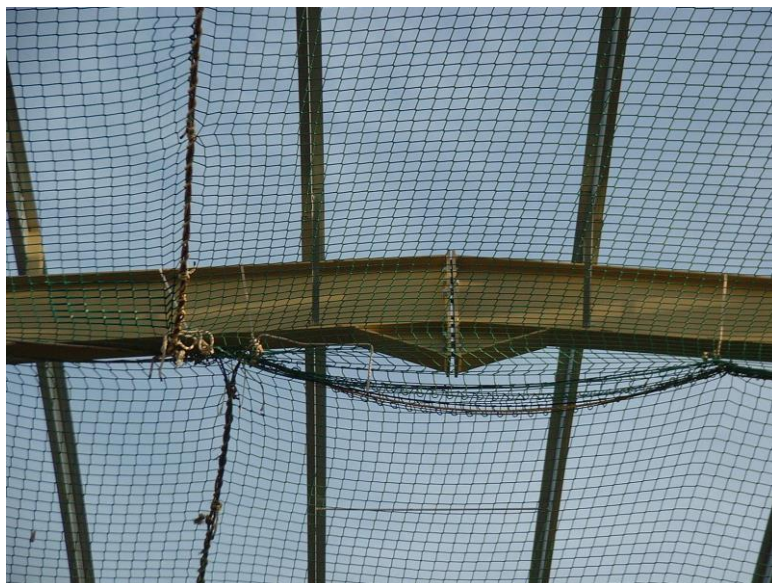
*Image 2: Incomplete structural connections*

In image 2, the apex connection of the rafters had been left incomplete as above, and then subsequently handed over to the roofing contractor to commence installation of the roof cladding.

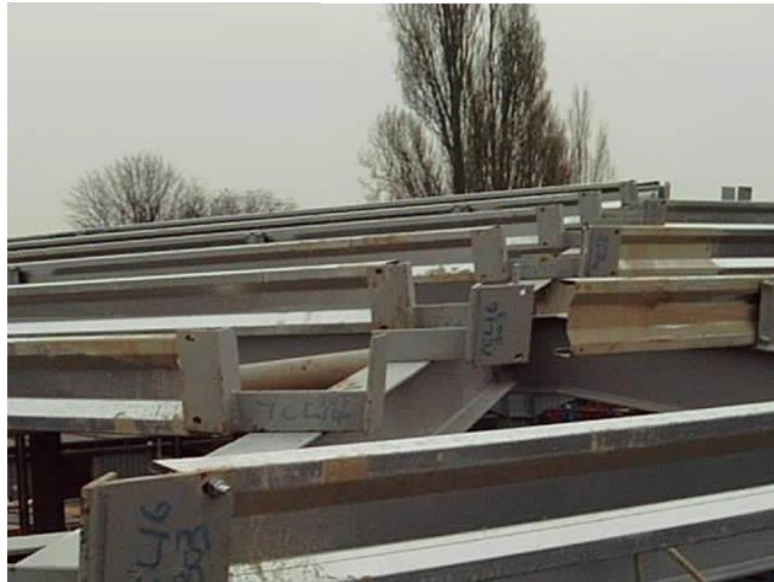
*Image 3: Incomplete structural connections*

Hip purlins not connected at hip rafter cleats; this not only affects structural capabilities but in addition, there are no structural 'cleaders', which are required to ensure non-fragility of the roofing assembly and an air tight junction being achieved. Purlins locations on hip rafters need consideration as they can clash with the internal gutters as is evident in image 4 below.

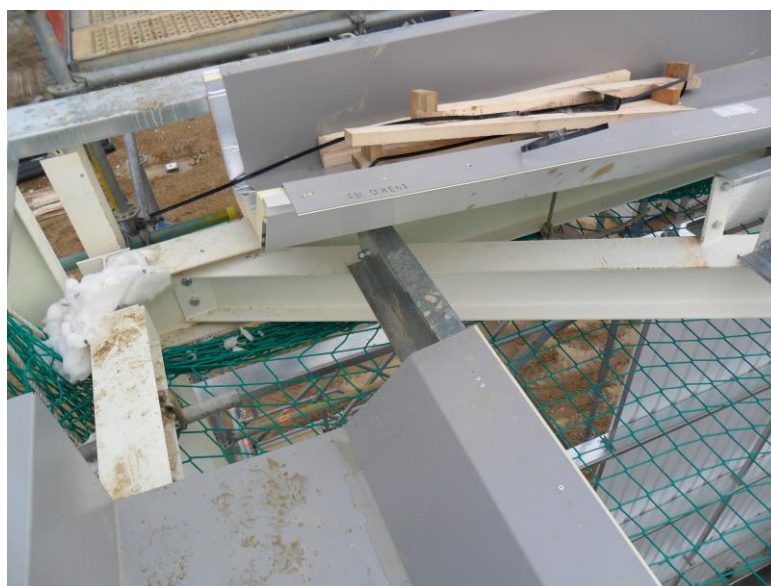
*Image 4: Purlin/gutter clash*

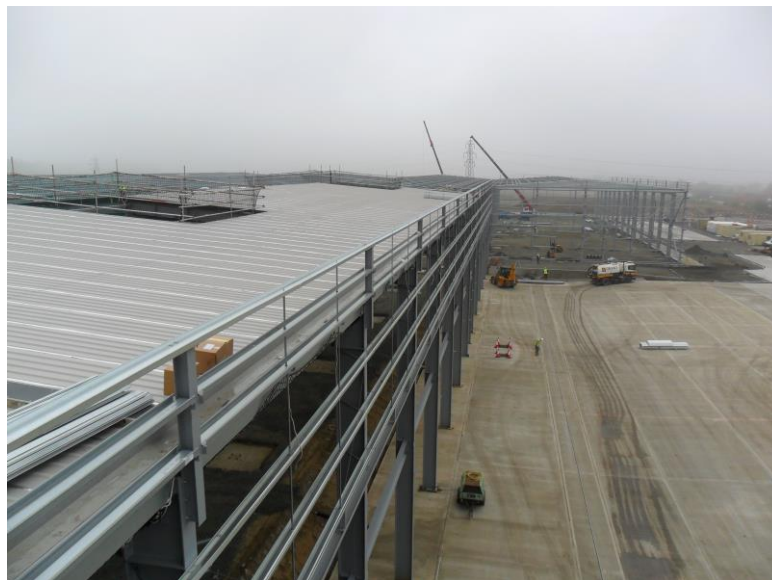
*Image 5: Primary and secondary steelwork properly installed*

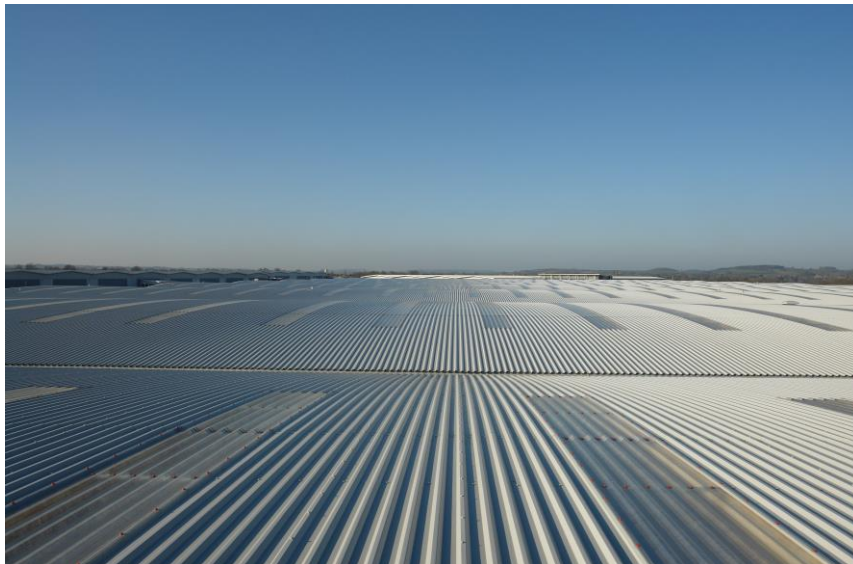
*Image 6: Roof cladding*

Examples of good installation and workmanship

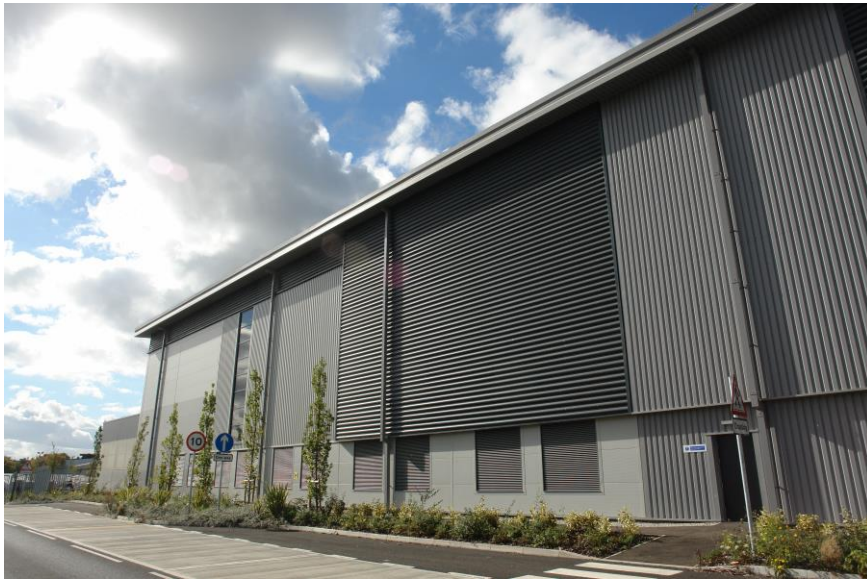
*Image 7: Wall cladding*
