## THE RE-SEALING OF JOINTS IN CAST IRON GUTTERS

## **INTRODUCTION**

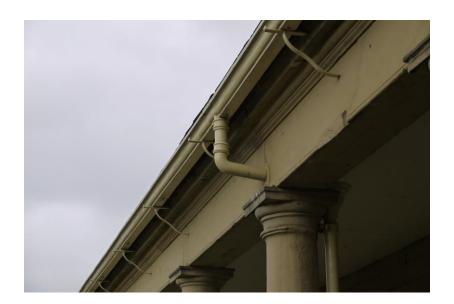
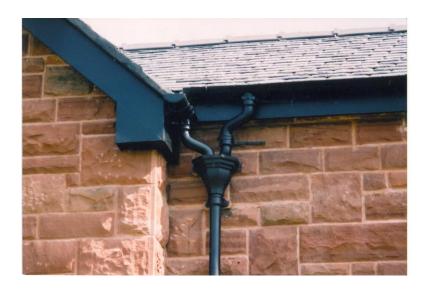
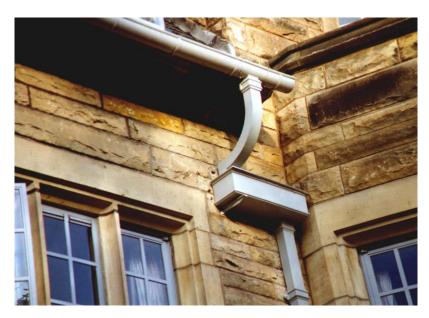
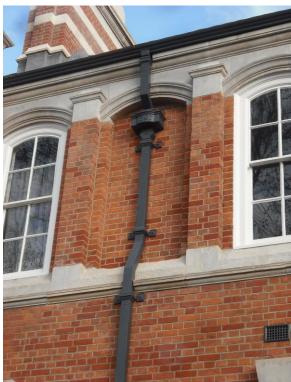
# Typical examples of re-sealed joints

In summary, for leaking gutter joints it is strongly recommended to cut through the
jointing bolts, thoroughly cleaning the gutter and reseal with a modern low modulus
silicone sealant which will ensure many years of trouble free life.
