**DISTRIBUTION CENTRE, WARRINGTON**  
**HAMBLESIDE DANELAW LIMITED**

Hambleside Danelaw's Zenon GRP rooflights were specified for the roof refurbishment of a distribution centre in Warrington.

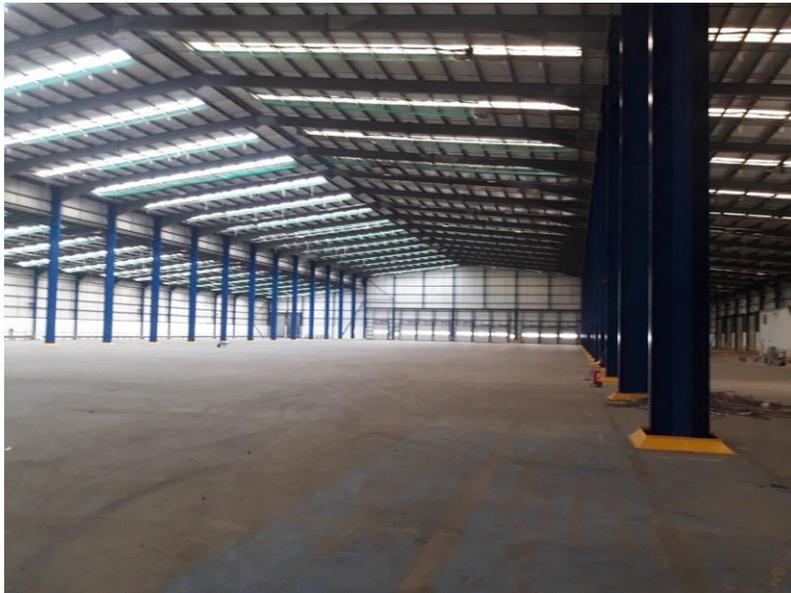
*Zenon rooflights installed to the left hand slope*

For the replacement of the 25+ year old outer sheet, the decision was to upgrade to the superior strength Zenon Evolution LC1. Unlike traditional GRP rooflights that are reinforced with short rovings, Evolution is formed using a continuous filament woven mesh of glass fibres providing very high tensile strength and resistance to tearing.

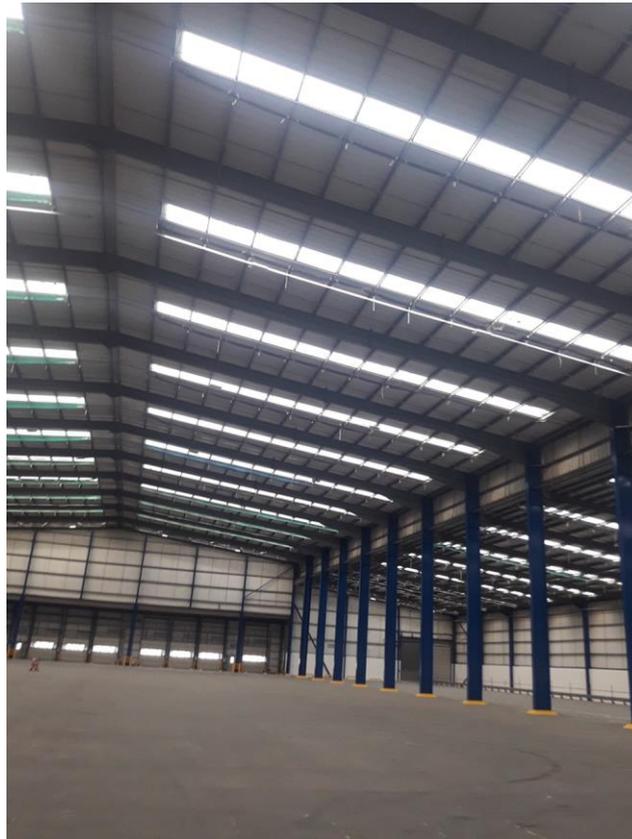
*Rooflight replacement internal*

This project involved an 8-12 person team over a period of 16 weeks, and included the supply and installation of safety netting and 1400 linear metres of edge protection with two Haki stair towers. The existing rooflights were replaced with rooflights using GRP Evolution LC1 Class 3; 140 runs at 22 metres in length.

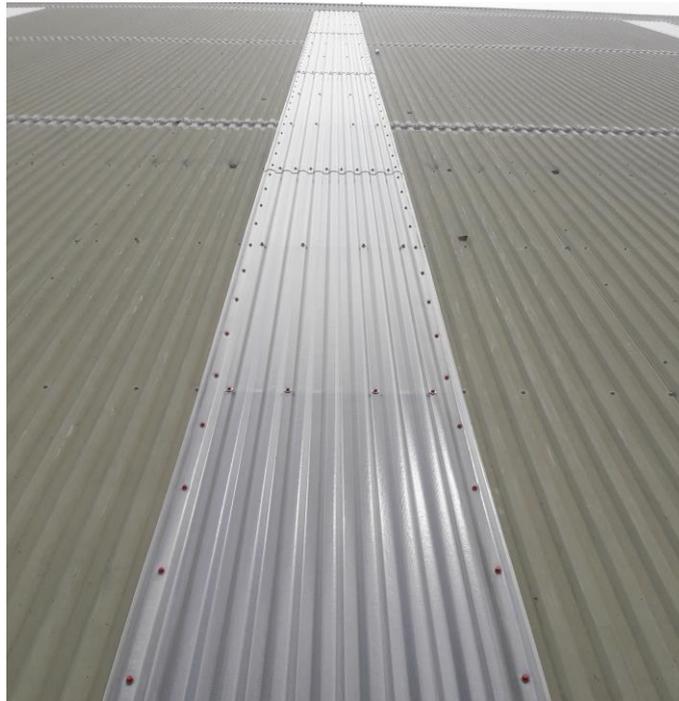
*Rooflight replacement complete*

The grinding off all cut edge corrosion was carried out to the roof sheet laps and mastic and basecoat was applied to the full roof - circa 8000 square metres. In addition, High Access carried out the clearance of all guttering to both low and high level roof areas, sealed all gutter joints and implemented a thorough cleaning of all roof sheets. Mobile Elevating Work Platforms (MEWPs) were provided to accommodate all works safely.
