**KNOTT OAK DAIRY FARM, SOMERSET  
FILON PRODUCTS LIMITED**

Over 300 square metres of Filon fair assembled insulating rooflights (FAIRs) double skin GRP rooflights have been installed on a new, high technology cow shed with integral milking parlour units at Knott Oak Dairy Farm in Ilminster, Somerset.

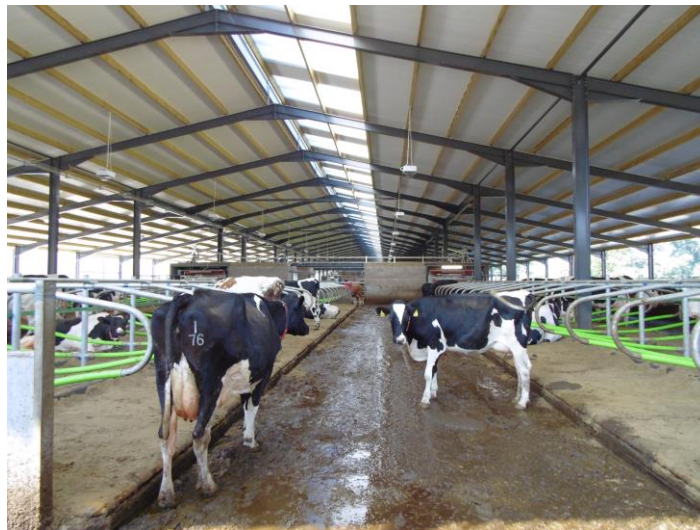
The choice of Filon's FAIRs double skin insulating rooflights further helps to maintain appropriate light levels with a consistently cool temperature inside the shed – with minimal requirement for auxiliary electric lighting.
